REPORT
OF
THE BOARD OF INQUIRY
into the accident at
Toronto International Airport,
Malton, Ontario,
to Air Canada DC8-CF-TIW aircraft
on July 5, 1970
held before
The Honourable Mr. Justice Hugh F. Gibson,
Commissioner.

to Air Canada DC8-CF-TIW aircraft

on July 5, 1970

Commissioner.

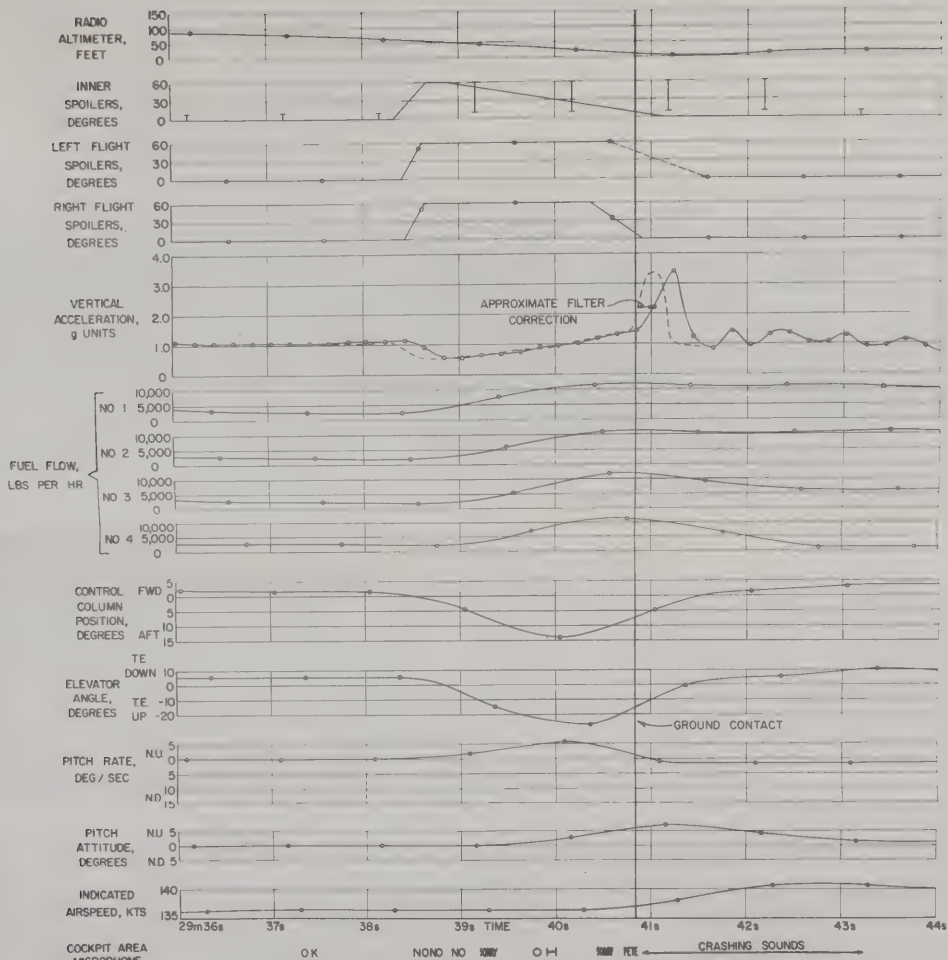
SCHEDULE 4 OF APPENDIX D

Immediately thereafter the First Officer instead of arming the ground spoilers by lifting up the knob of the spoiler actuating lever, pulled the lever aft to the aft extend position, which caused the ground spoilers to be deployed immediately thereafter. As a result, the aircraft lost lift immediately and developed a vertical acceleration of approximately (-) $\frac{1}{2}g$.

VARIAION OF CRITICAL PARAMETERS DURING SPOILER DEPLOYMENT AND TOUCHDOWN
WITH SYNCHRONIZED VOICE INFORMATION

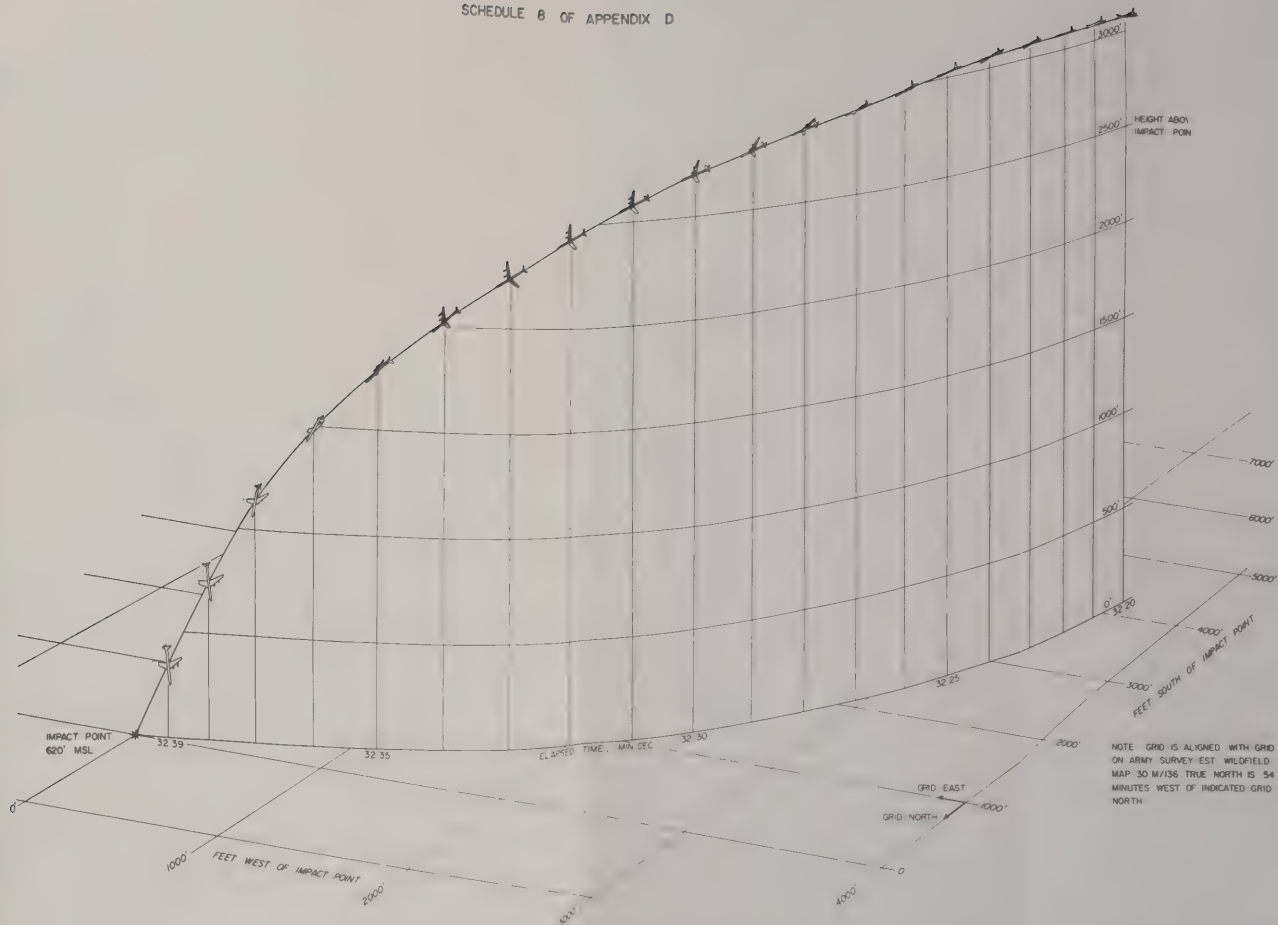
SCHEDULE 8 OF APPENDIX D

RECONSTRUCTION OF CF-TIW MOTION IN THE LAST 19 SECONDS BEFORE IMPACT

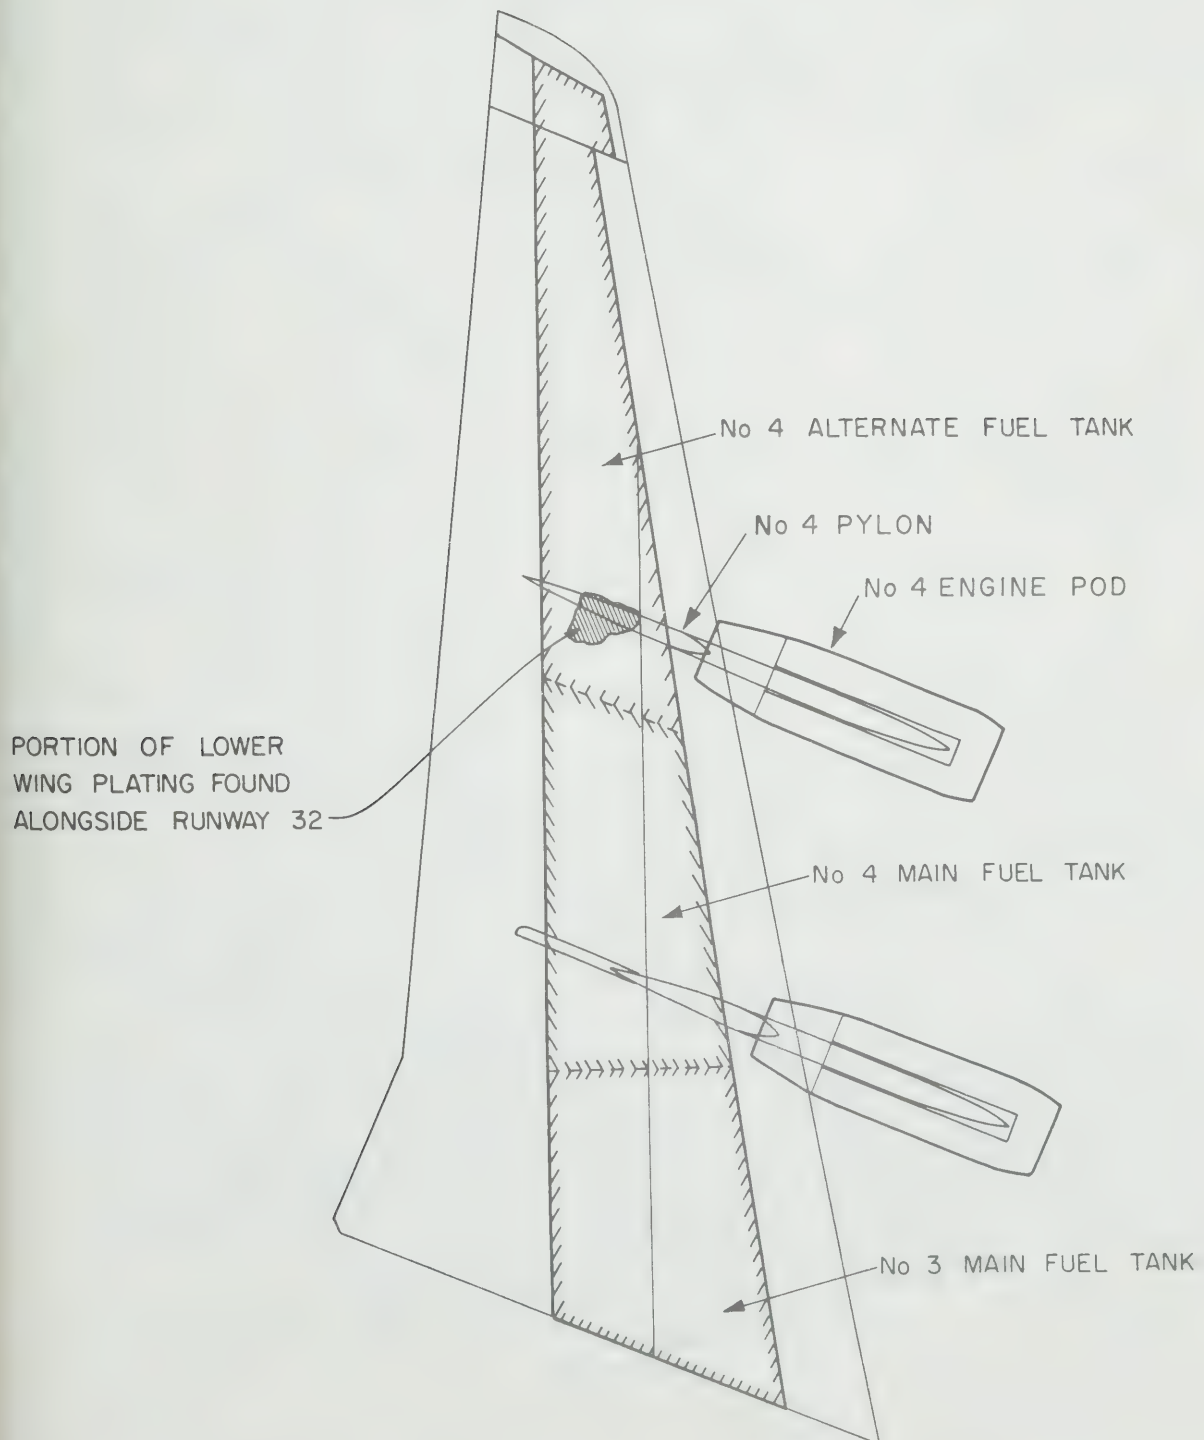
SCHEDULE 17 OF APPENDIX D

As a result of this striking of the runway, number 4 engine and pylon, the horizontal attachment angles and the wing plating failed and the engine and pylon and section of the wing plating adjacent to number 4 pylon, were torn off, and a large hole was left in the bottom of the wing plate of number 4 alternate fuel tank. In addition, number 3 engine pylon to the wing vertical attachment plate bolts was sheared completely.

A heavy landing, with sufficient force to mark the runway at the point of contact of the wheels and tail bumper, number 4 engine pod, pylon and a portion of lower wing plating to break away from the aircraft (see Schedule 17 of Appendix "D"). There was fire on the ground, and fuel was observed streaming from the right wing in the climb segment flight following the touch down. Fire and smoke were observed in the right wing during the climb. Approximately

EXTRACT FROM ENQUIRY EXHIBIT 28 SHOWING PORTION OF LOWER
RIGHT WING PLATING OF CF-TIW WHICH FAILED AT THE PYLON ATTACHMENT

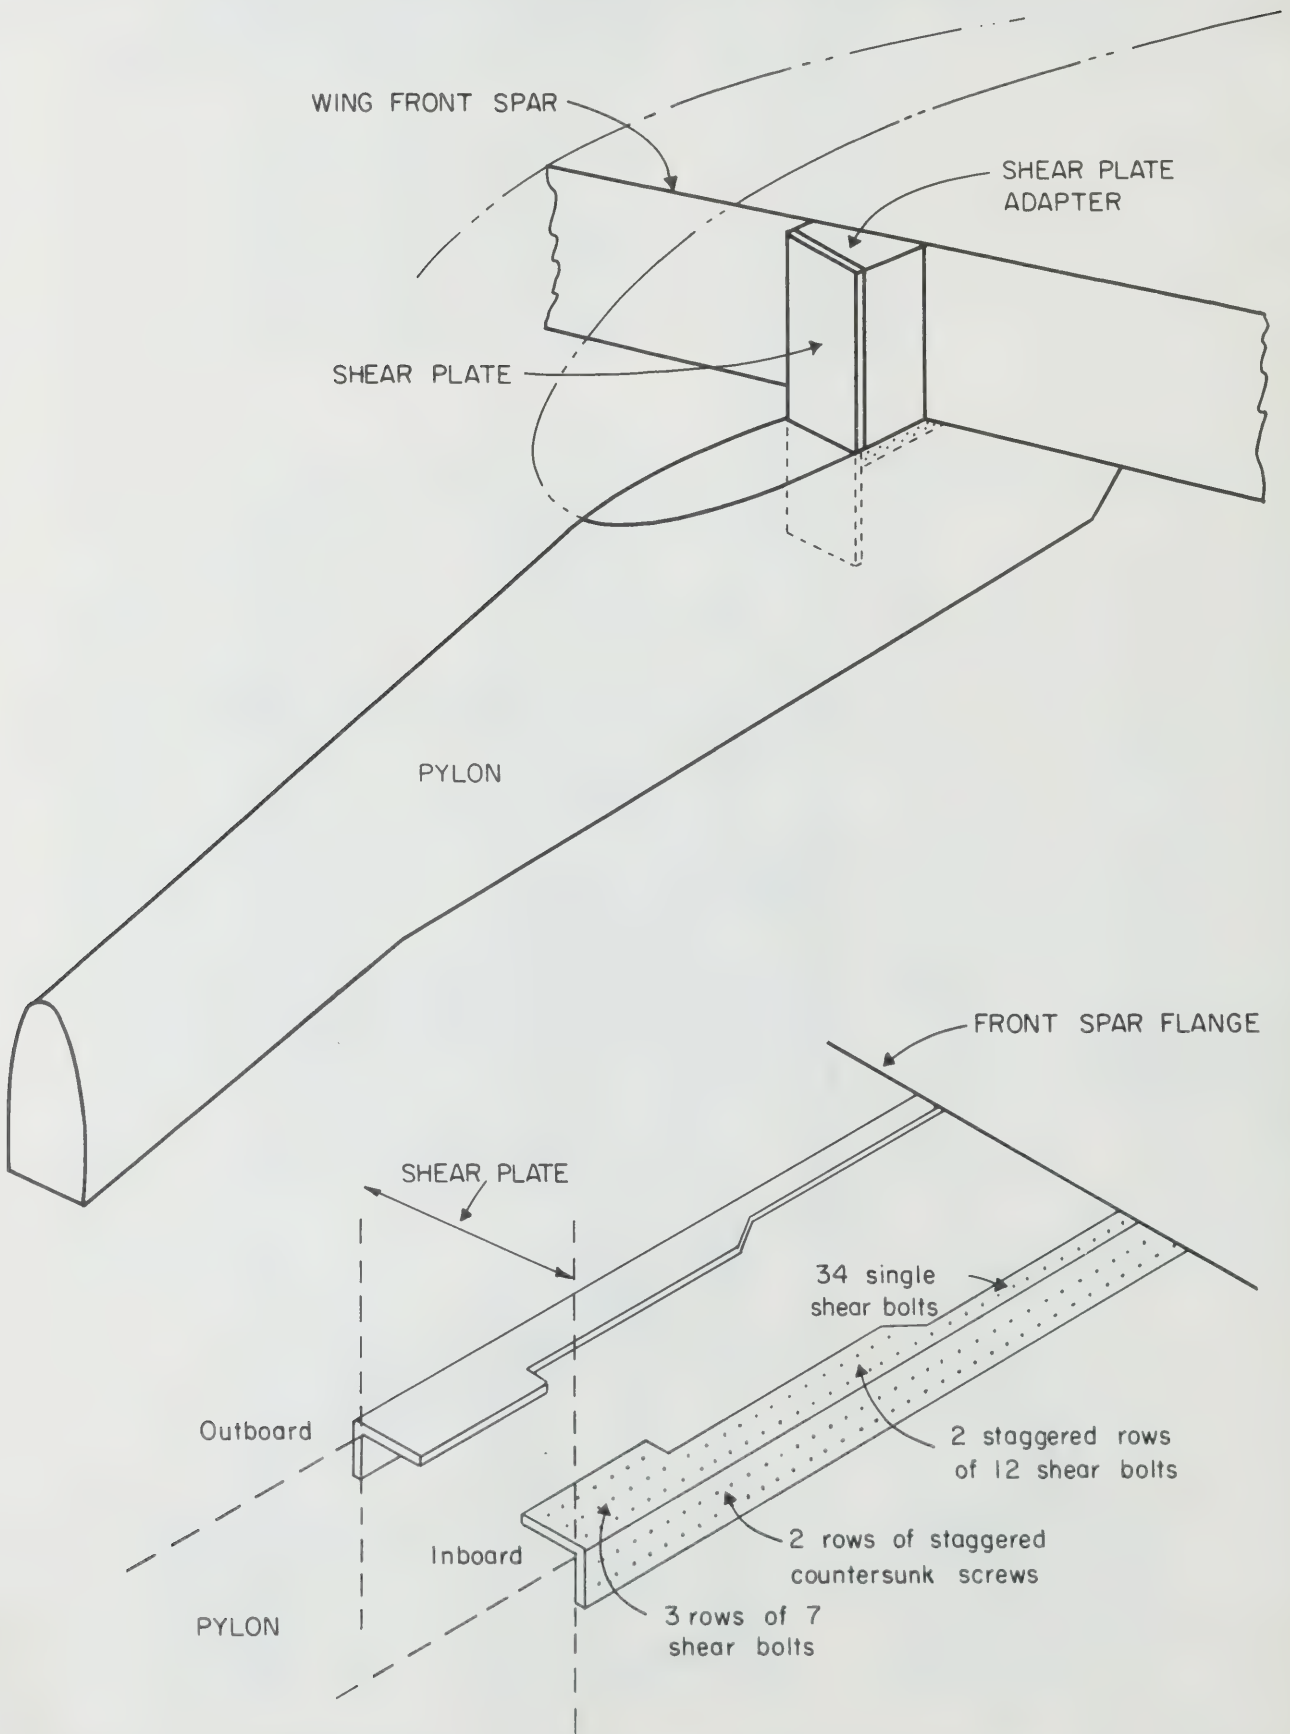
SCHEDULE 18 OF APPENDIX D
SKETCH OF DETAILS OF PYLON TO WING ATTACHMENT FITTINGS

The design philosophy of this aircraft included provisions for the separation of the engine pod and pylon from the aircraft structure when vertical loads of 7 g were experienced. This is accomplished by stressing the pylon-to-wing attachments so that the (shear) bracket at the front spar fails first, under vertical load, followed by a progressive failure of the bolts, front to rear, in the horizontal (thrust) attachment (see Schedule 18 of Appendix "D"). Unfortunately, in this accident the horizontal attachments did not perform in the manner prescribed. Some of the bolts at the rear did not fail, in sequence, and, as a result loads were transmitted to the wing which caused a portion of the wing plating - which is also the floor of the number 4 (alternate) fuel tank - to be carried away with the engine pod and pylon. From the evidence, it has been suggested that the number 4 pod did not fail directly downwards, a side component of the forces twisted the pylon to the right, and prevented the attachments from failing cleanly. As a result, a hole approximately four feet long and two feet wide forward, increasing to four feet at the rear, was left in the bottom of the wing plate of number 4 alternate fuel tank.

² The evidence from the wreckage showed that the vertical shear attachments of this engine were seriously damaged in the first landing impact.
